# ChiCom Submarine

# Construction

CHICOM |
SUBMARINE
CONSTRUCTION

TCS - 1538/65
IB - 35/65
9 March 1965
Copy #

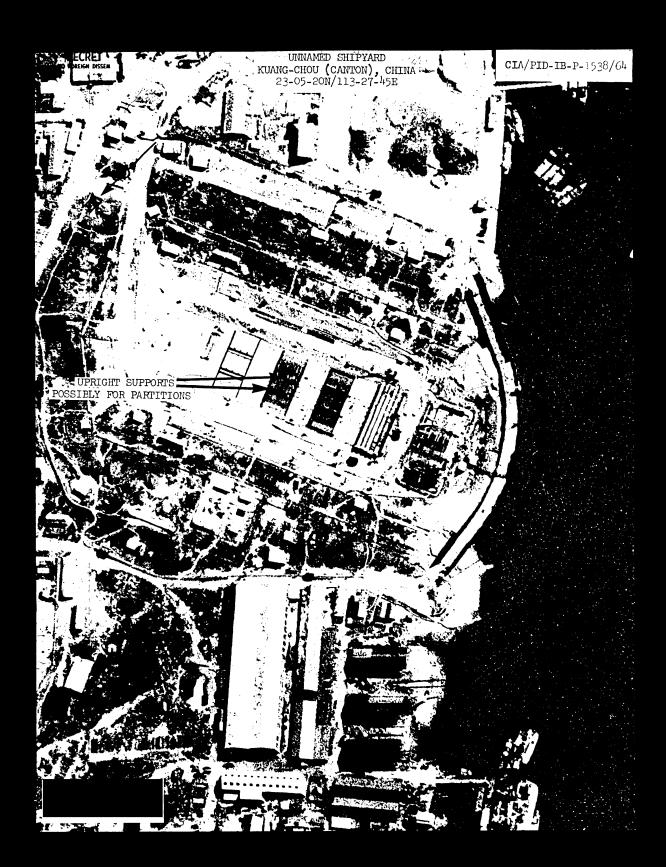
UNNAMED SHIPYARD
KUANG-CHOU (CANTON), CHINA
23-65-20N/113-27-45E CIA/PID-IB-P-.537/64 MERCHAUT THIP PROBABLE CONCRETE BATCHING PLANT NEWLY COVERED WAYS
